Minolta Maxxum STsi Tripod Socket Replacement

Replace the tripod socket for your Minolta Maxxum STsi.

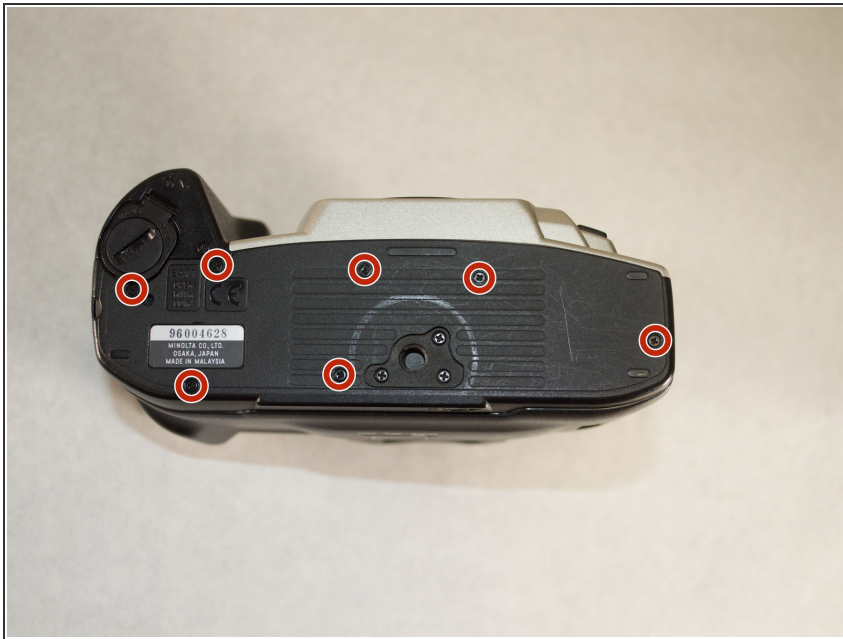
Step 1 — Bottom Panel

- Remove the seven black Phillips #00 5.0 mm screws.

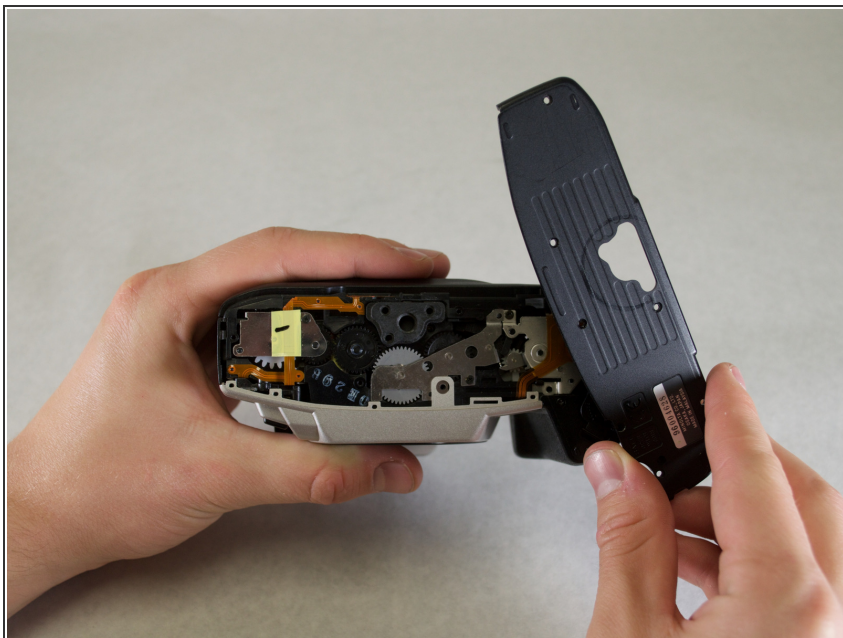
Step 2

- Gently remove the bottom panel using your fingers.

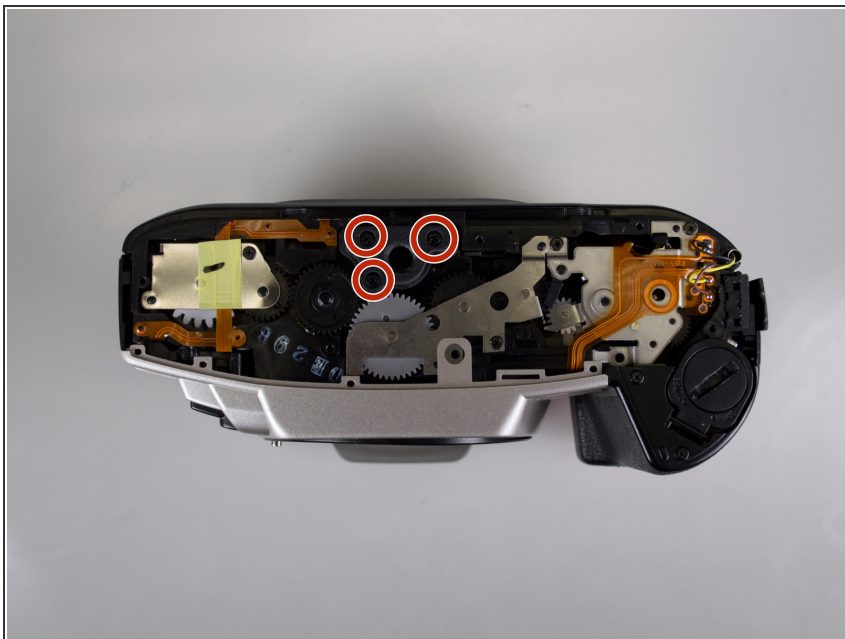
Step 3 — Tripod Socket

- Remove the three black Phillips #00 6.25 mm screws from the tripod socket to remove the tripod socket.

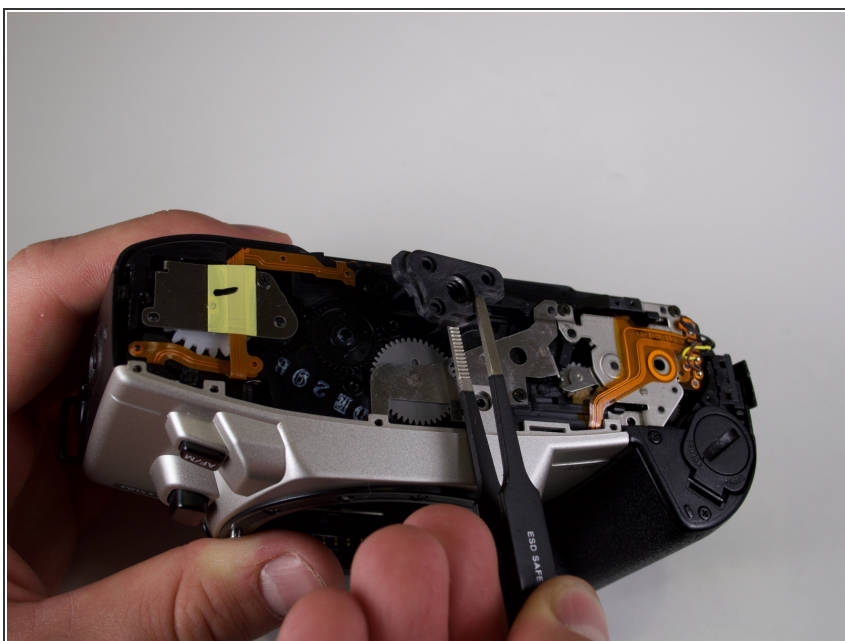
Step 4

- Use tweezers to gently remove the tripod socket.
